Intel® Pentium® M Processor on 90 nm Process with 2-MB L2 Cache

Specification Update

Document Number: 302209-017

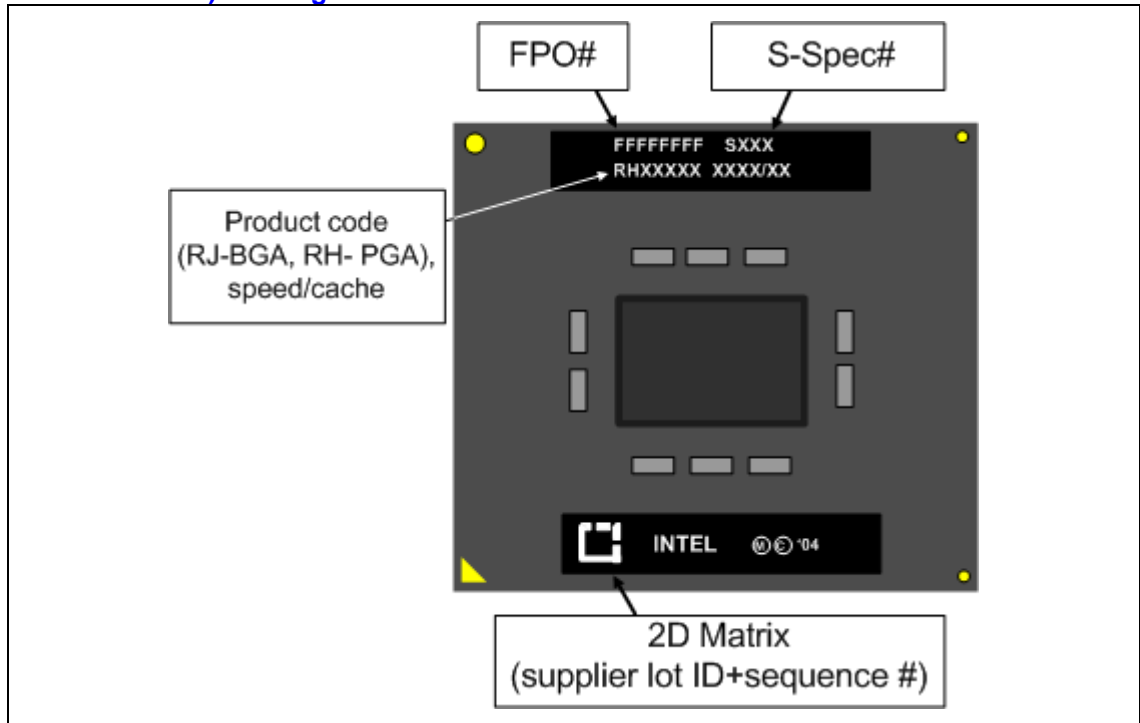
Figure 1. Intel® Pentium® M Processor on 90 nm Process with 2-MB L2 Cache (Micro-FCPGA/FCBGA) Markings

The Intel Pentium M Processor on 90 nm process with 2-MB L2 cache may be identified by the following component markings:
